FLIGHT TEST-WHIRLING ARM CORRELATION OF RAIN EROSION RESISTANCE OF MATERIALS

TECHNICAL REPORT AFML-TR-67-420

SEPTEMBER 1968

AIR FORCE MATERIALS LABORATORY
AIR FORCE SYSTEMS COMMAND
WRIGHT-PATTERSON AIR FORCE BASE, OHIO

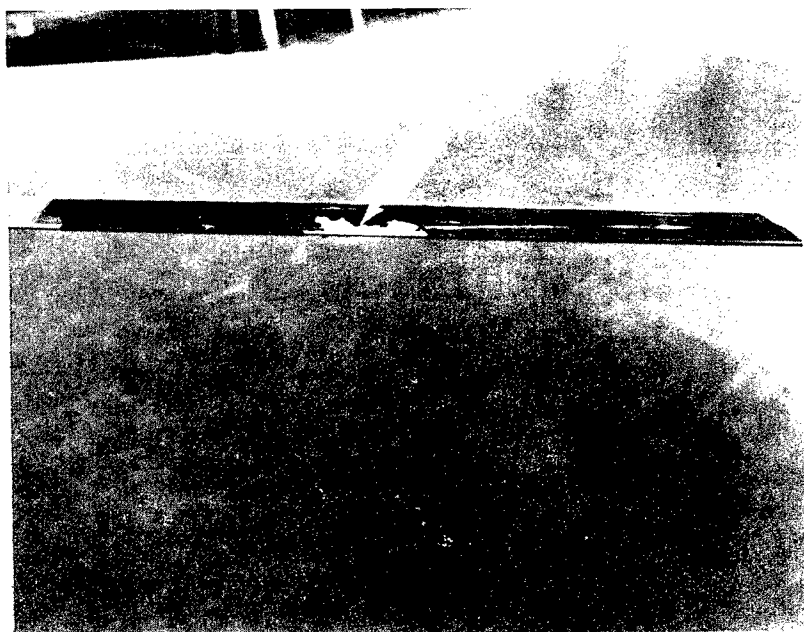
The first visible damage received by this coating was noted after Flight 7. Hail approximately the size of marbles was encountered on at least two penetrations. Figures 13 and 14 show that one-third of the leading edge of the sample was removed from the top and bottom of the right stabilizer. The neoprene on the left stabilizer received similar damage on this flight as can be seen in Figures 15 and 16. Only bare metal remained at the exposed sections. Both coatings had been torn from the stabilizer in small segments based on the jaggedness of the edge of the remaining samples. The sample on the left stabilizer was considered to have failed on Flight 7; however, the test continued with the sample on the right stabilizer. The postflight inspection for Flight 13 showed that three-fourths of the leading edge of the right stabilizer initially covered by neoprene was now exposed (Figures 17 and 18). The neoprene adhered to the bottom of the stabilizer but gradually peeled from the top of the stabilizer during Flights 12 through 16. Testing was terminated on this sample after Flight 16 because the entire leading edge and most of the top surface had eroded away (Figures 19 and 20).

Figure 13. Results of Hail Impact on the Specification Neoprene Sample on Upper Surface of Right Horizontal Stabilizer

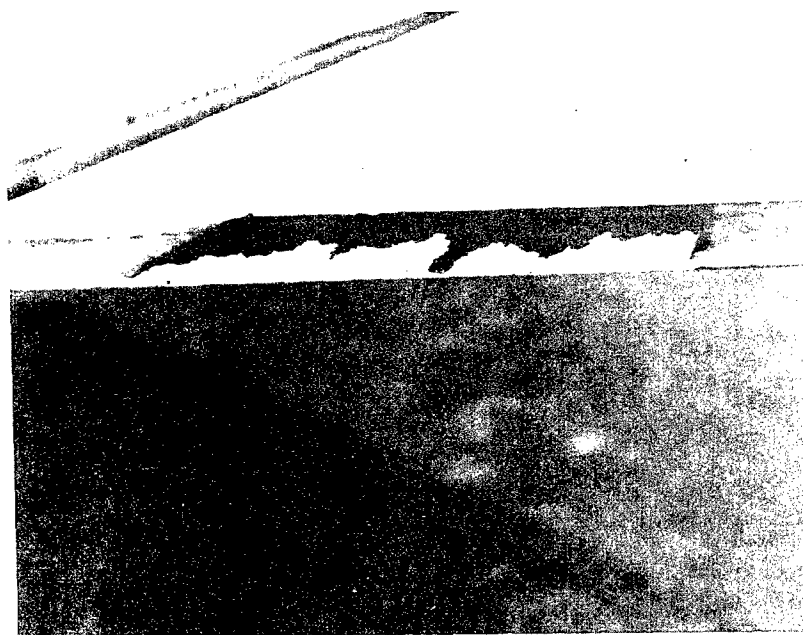
Figure 15. Specification Neoprene on Inboard Section of Left Stabilizer After Flight 7

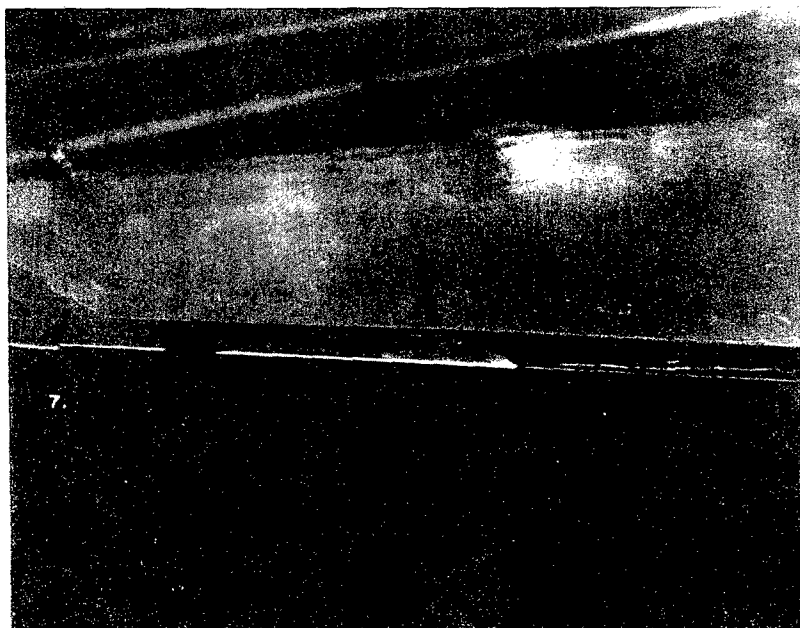
Figure 17. Erosion of Specification Neoprene on Right Stabilizer After Flight 13

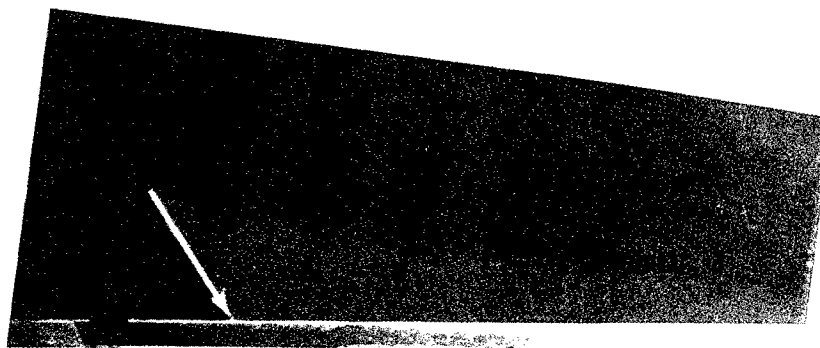
Figure 18. Condition of Specification Neoprene Sample on Lower Surface of Right Stabilizer After Flight 13

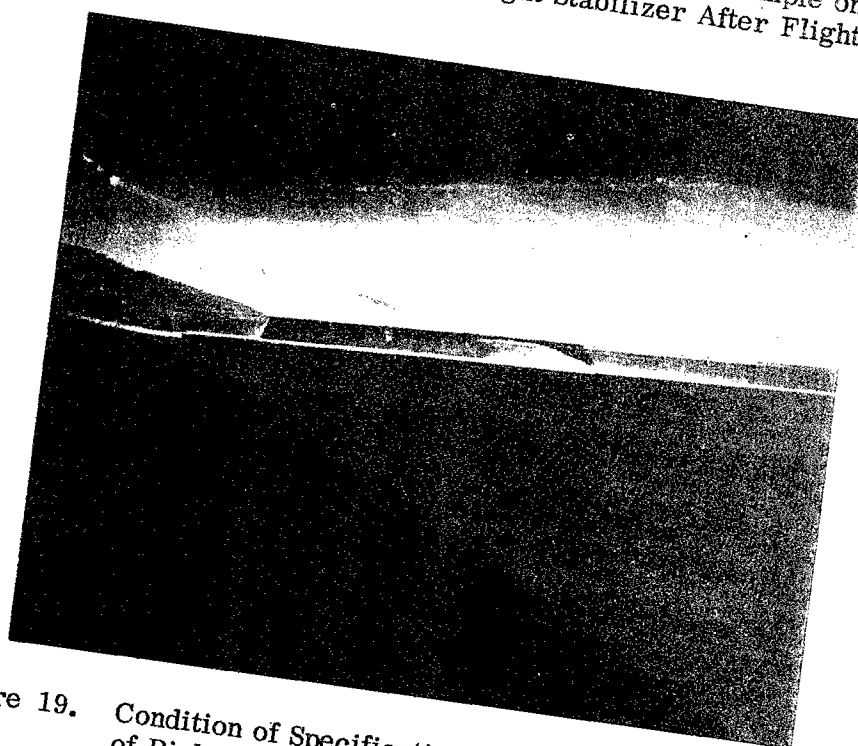
Figure 19. Condition of Specification Neoprene on Upper Surface of Right Stabilizer After Flight 16

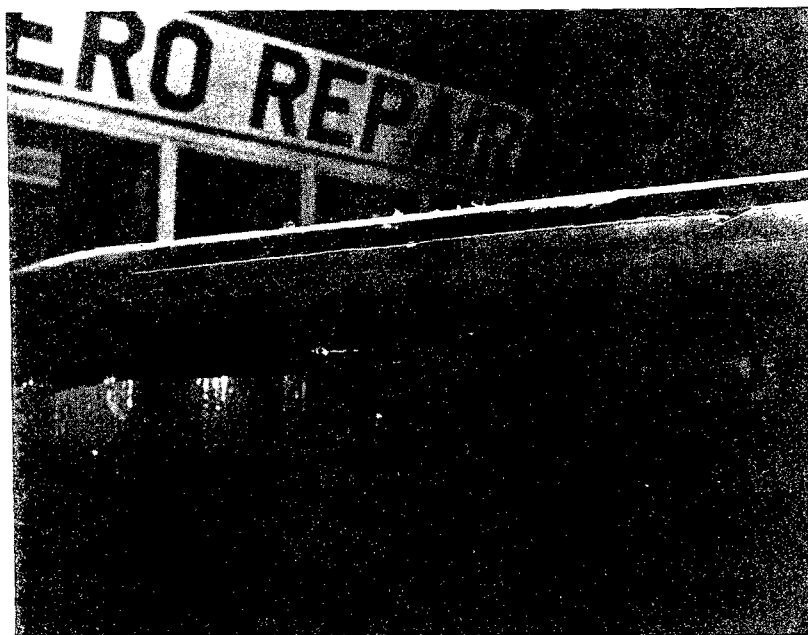
Figure 20. Condition of Specification Neoprene on Lower Surface of Right Stabilizer After Flight 16

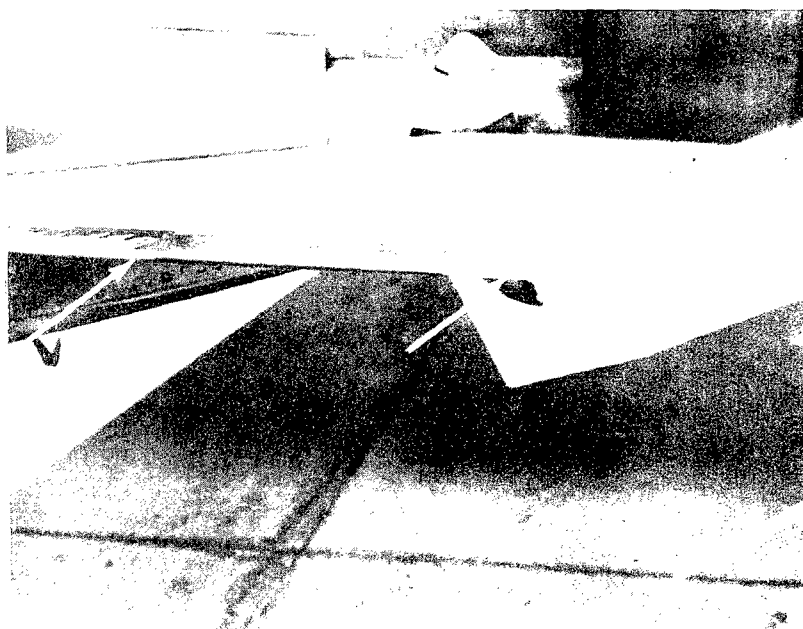
Figure 21. The Clear Urethane Sample on Leading Edge Shows an Approximate One-Inch Peel at End of Flights; the Adjacent Pigmented Urethane on Stabilizer Shows No Adverse Effects at the End of Program

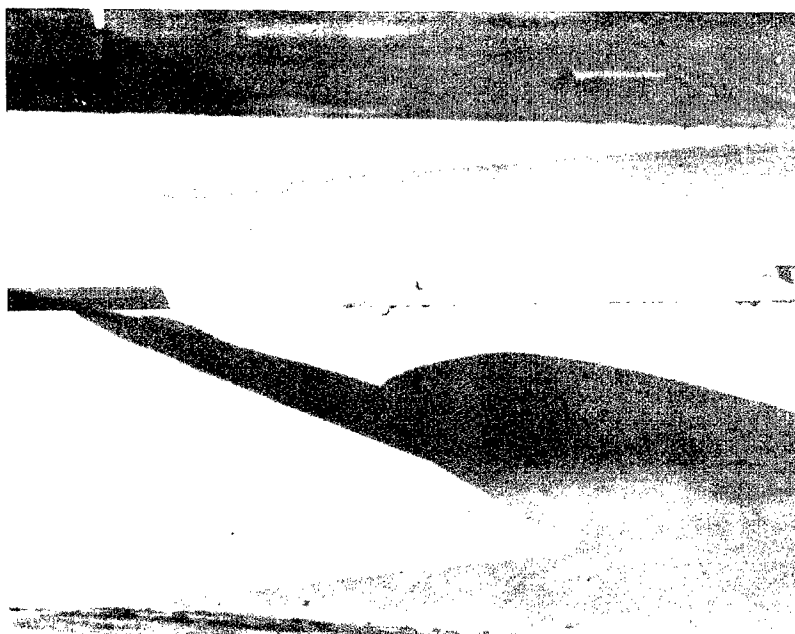
The pigmented urethane on the right stabilizer withstood the adverse conditions until its bond to the metal was broken when the inboard, adjacent urethane sample was blown from the aircraft during Flight 20. The sample peeled 4 inches during the next two flights. Figures 23 and 24 show the condition of this sample

Figure 23. Peeled Segment of Pigmented Urethane on Right Stabilizer After Last Thunderstorm Flight

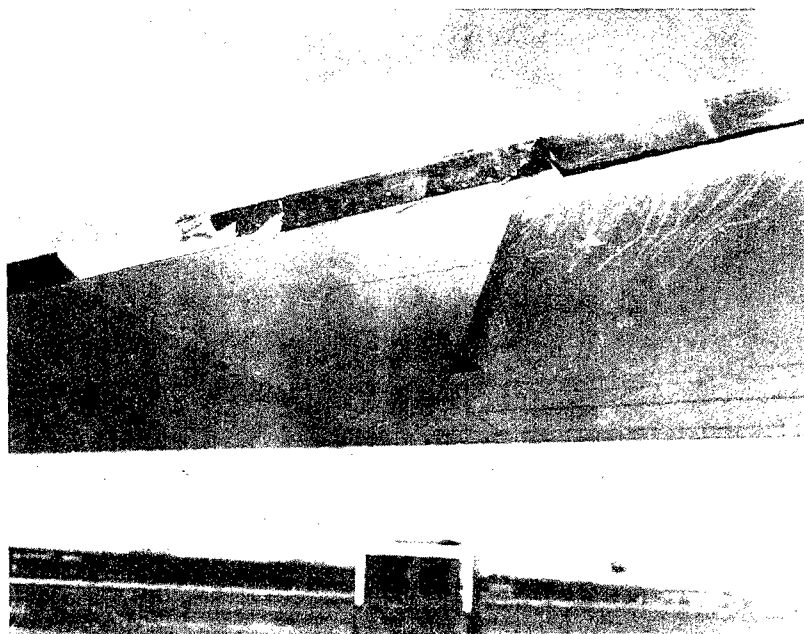
Figure 24. Final Condition of Pigmented Urethane Sample on Lower Surface of Right Stabilizer

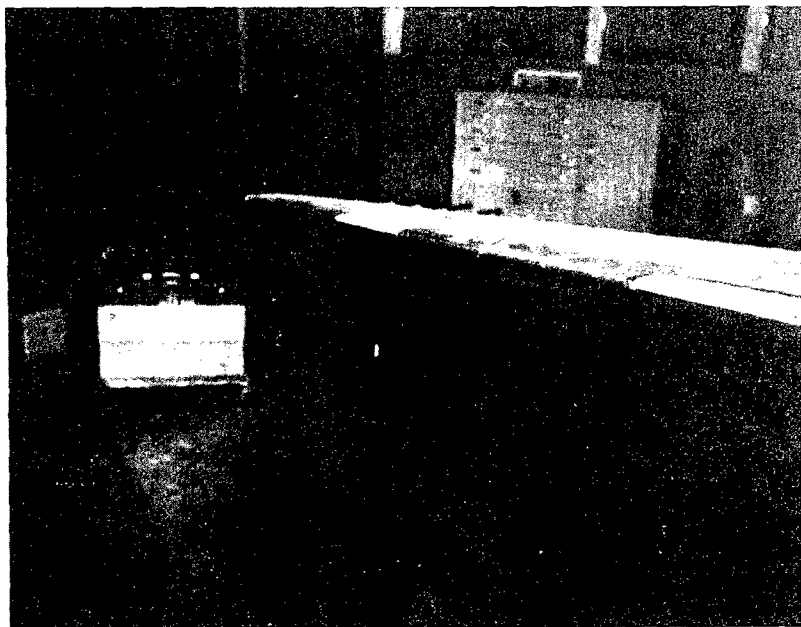
Figure 25. Peeling of Clear Urethane on Right Stabilizer Indicated by Arrow Was Attributed to Overlapping of the Nickel Sample

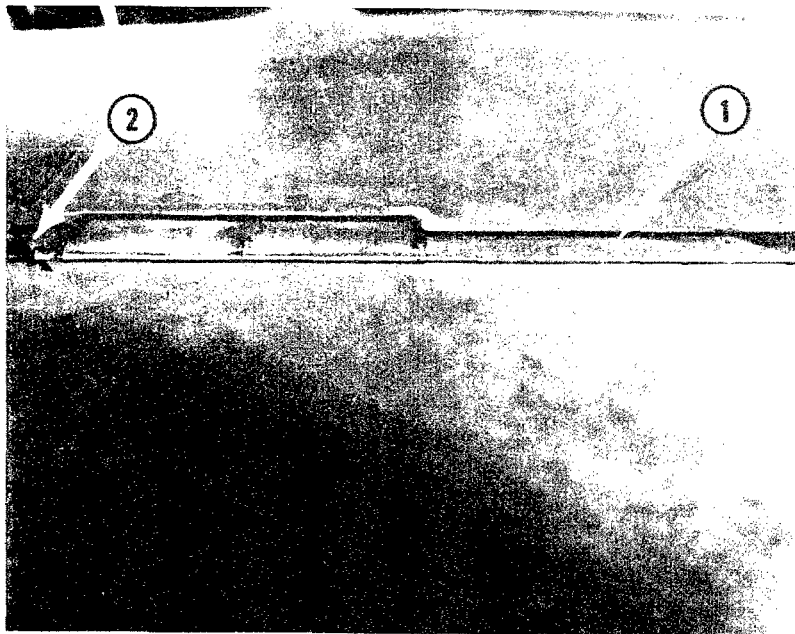
Figure 26. Sections of Clear Urethane Tape (1) Were Torn From Sample on Right Stabilizer During Hail Encounter on Flight 7 and Clear Urethane (2) Was Peeled an Additional Amount on the Inboard Edge

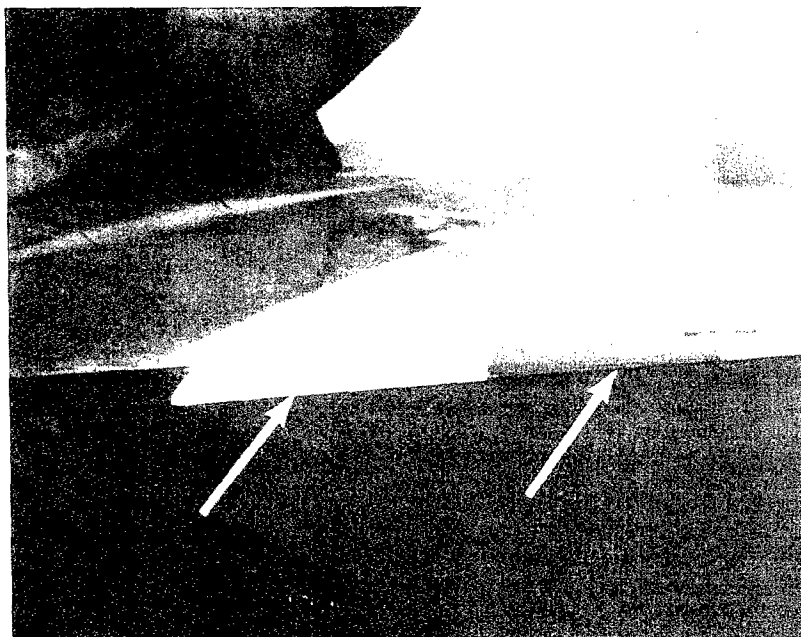
Figure 30. Pigmented Urethane and Clear Urethane on Left Stabilizer Completed the Tests With No Adverse Effects

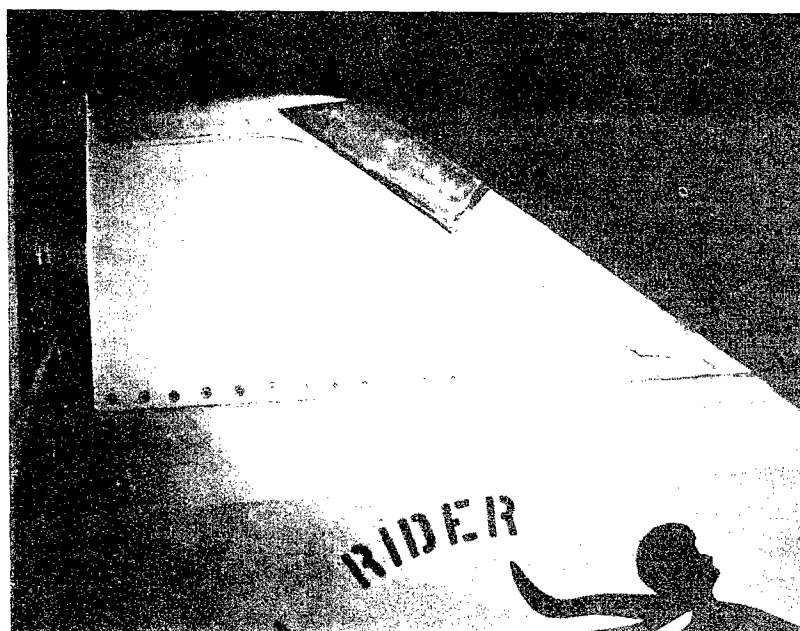
Figure 31. First Sign of Breakdown of Nickel Sample on Leading Edge of Vertical Stabilizer After Flight 7

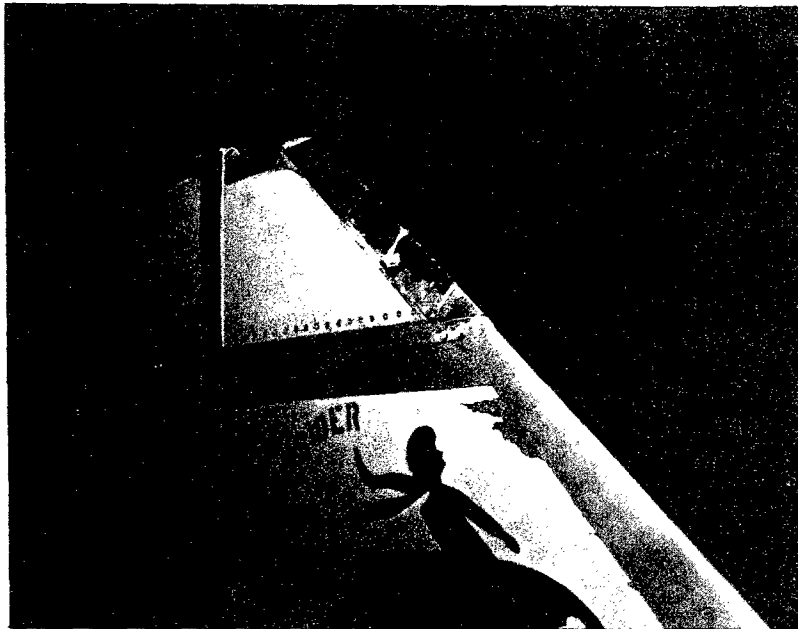
Figure 32. Increased Damage to Nickel Sample on Vertical Stabilizer as of Flight 16

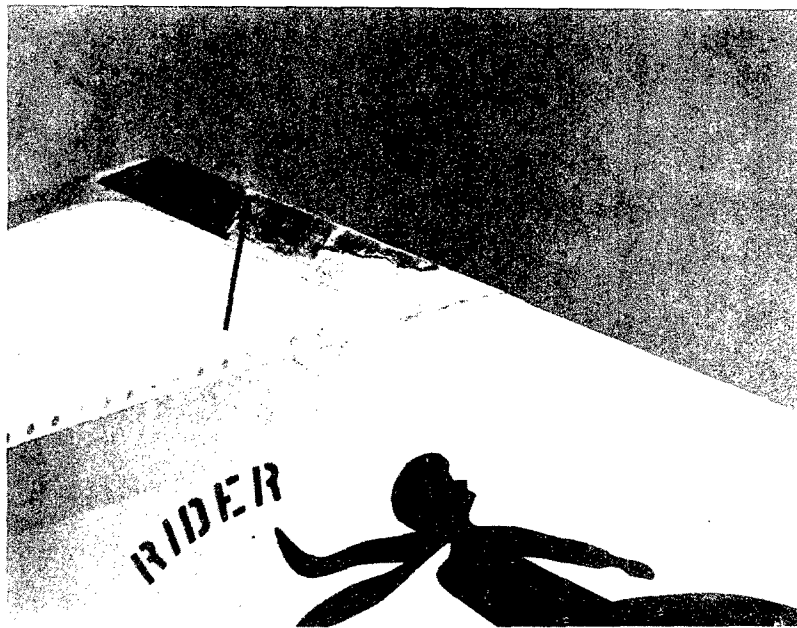
Figure 33. Approximately Two-thirds of the Nickel Sample on the Right Side of the Vertical Stabilizer Was Lost by the End of Program; the Urethane Sample Above the Nickel Had Little Damage

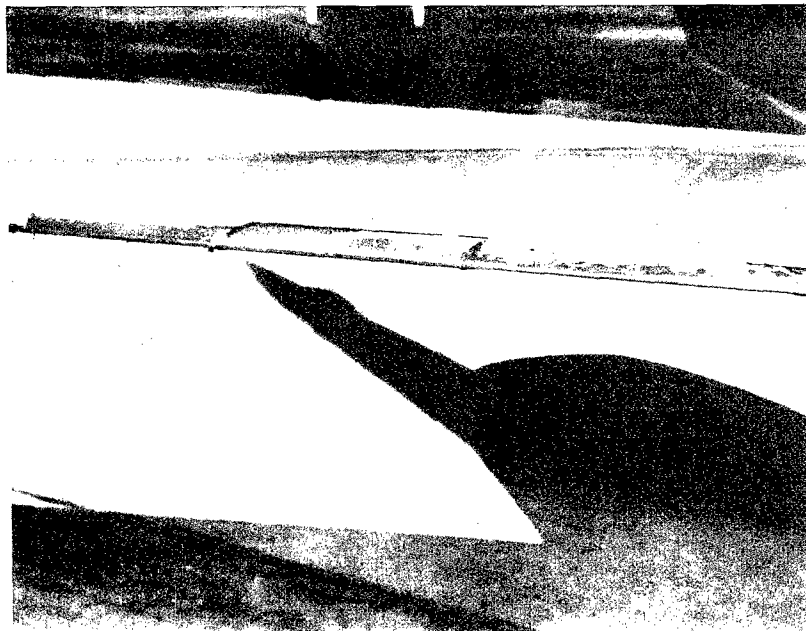
Figure 34. Damage to Nickel Sample on Right Stabilizer Upon Completing Tests

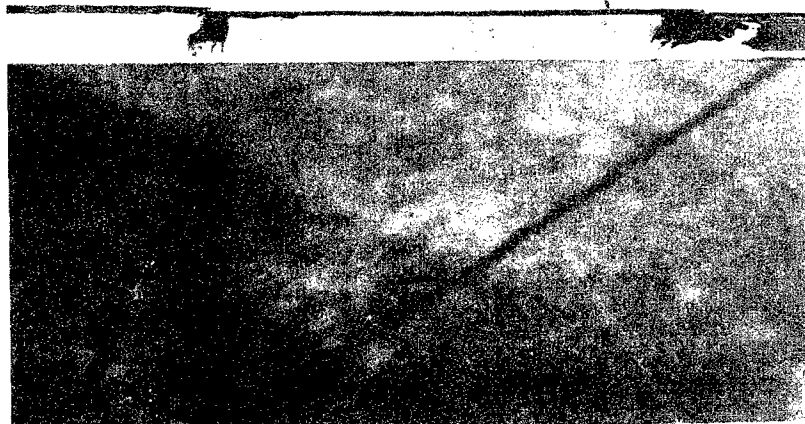
Figure 35. All Urethane Tape on Upper Surface of Left Stabilizer Was Lost During Flight 7

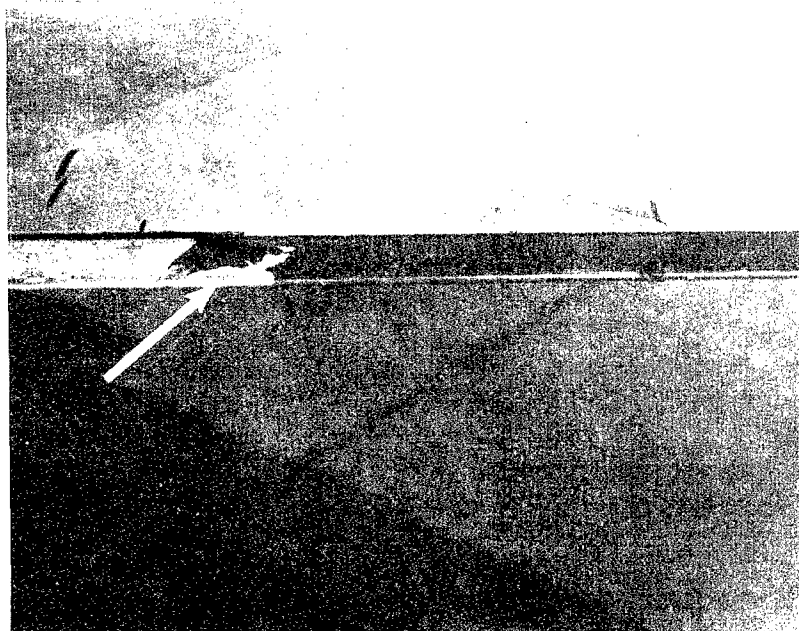
The first visible sign of damage was peeling of the inboard edge of the sample on the left stabilizer which occurred during Flight 7 (Figures 38 and 39). This partial breakdown continued through Flight 13 at which time approximately one-third of the shoe had been sheared away (Figures 40 and 41). This loose segment was not brittle nor did it have any surface roughness. (The shoe retained these characteristics until complete removal occurred.) The failure of this sample appears due to the inability of the adhesive to hold the shoe to the metal. This was particularly noticeable during the Flight 16 postflight (Figures 42 and 43). The adhesive along the leading edge was adhering to the loosened section of Estane, but no adhesive remained on the exposed metal surface. This shoe was lost during flight 17. The Estane boot on the right stabilizer showed slight peeling of the inboard edge as a result of Flight 16; however, the peel was too insignificant to photograph. This sample remained glossy with no surface roughness or breaks throughout the test phase except for the peeling of the inboard edge which had increased about an inch on the top and bottom stabilizer surfaces (Figures 44 and 45).

Figure 38. Stain on Inboard Edge of Upper Surface on Left Stabilizer Peeled as a Result of Hail Encounter on Flight 7

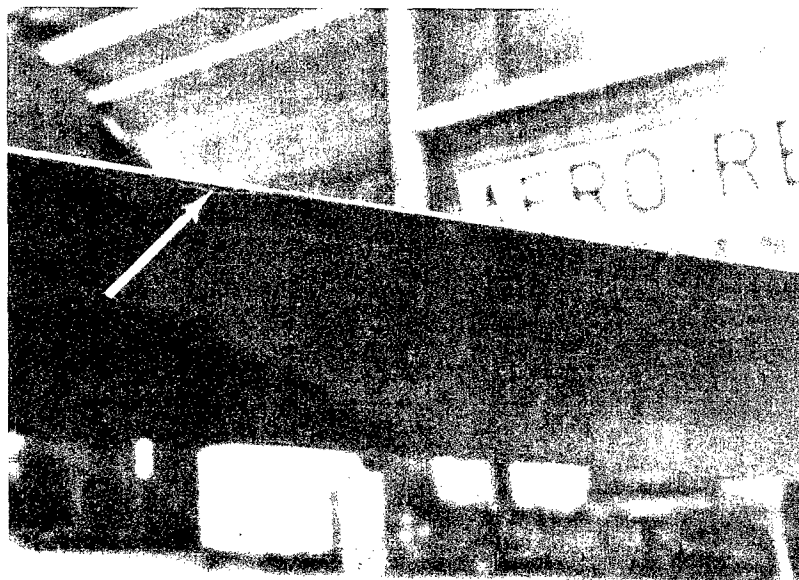
Figure 39. Stain on Lower Surface of Left Stabilizer Received Slight Damage During Flight 7

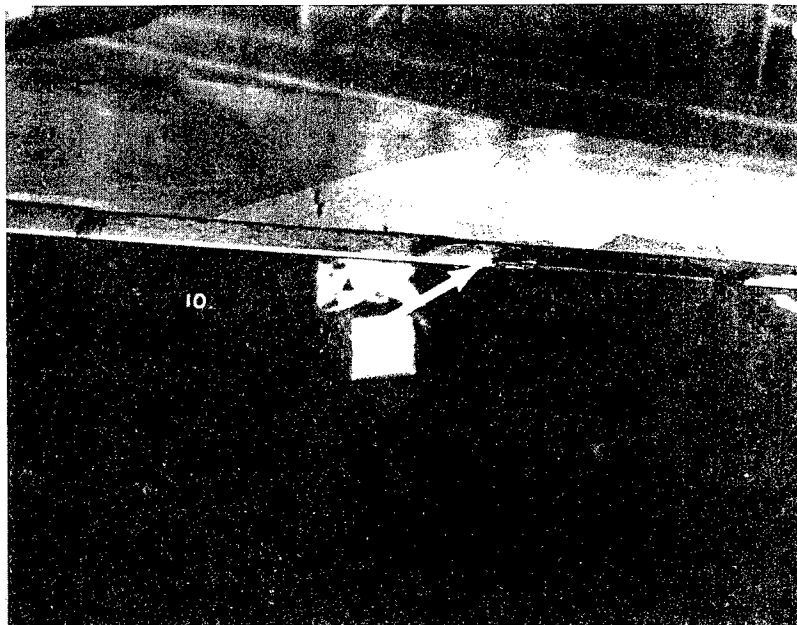
Figure 40. Additional Peeling of Estane on Upper Surface of Left Stabilizer After Flight 13

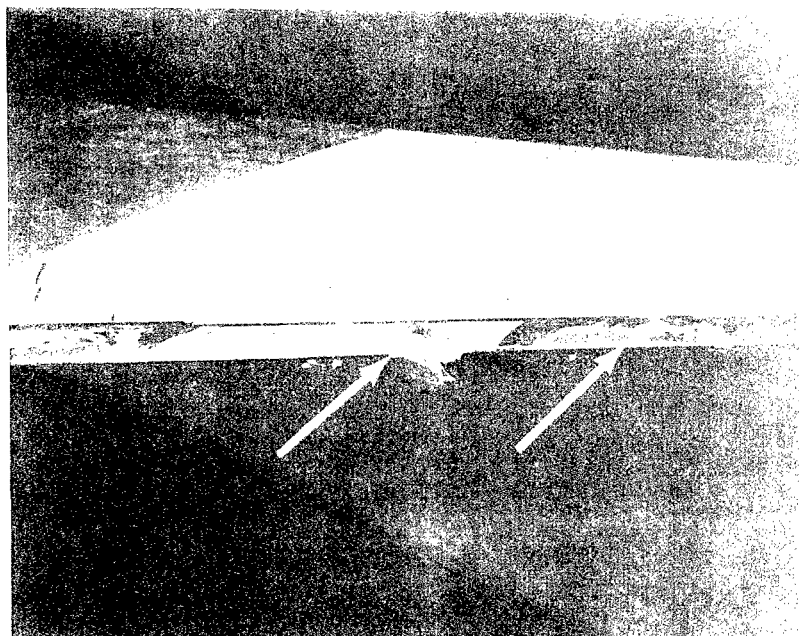
small cuts received were enlarged during the following flights as can be seen in the Flight 13 postflight photograph of the sample (Figures 50 and 51). The final damage was received and photographed after Flight 16 (Figures 42 and 43). The test was considered to be over for this sample since the entire leading edge had been destroyed.

Figure 42. Estane Boot Almost Completely Peeled From Left Stabilizer and Adjacent Neoprene With Insignificant Amount Remaining on Leading Edge on Flight 16

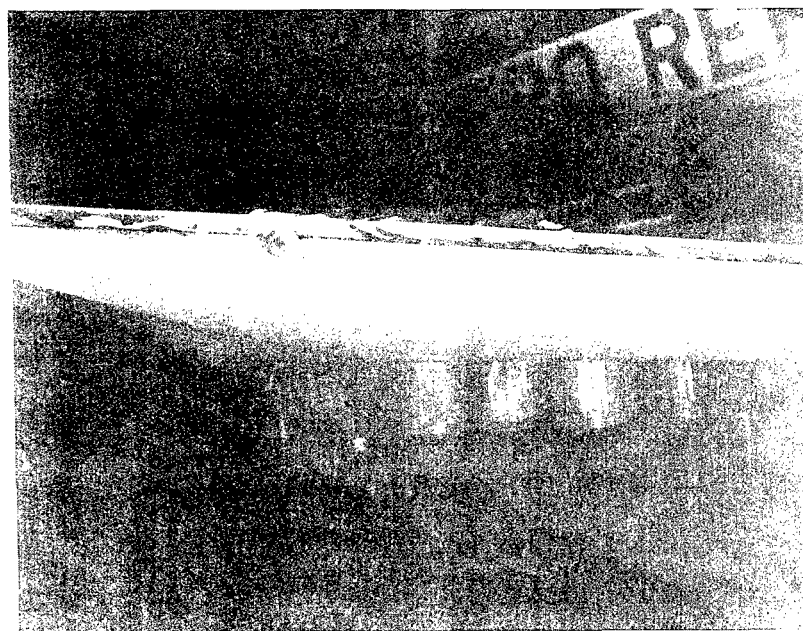
Figure 43. Damage to Estane and Neoprene on Lower Surface of Left Stabilizer on Flight 16

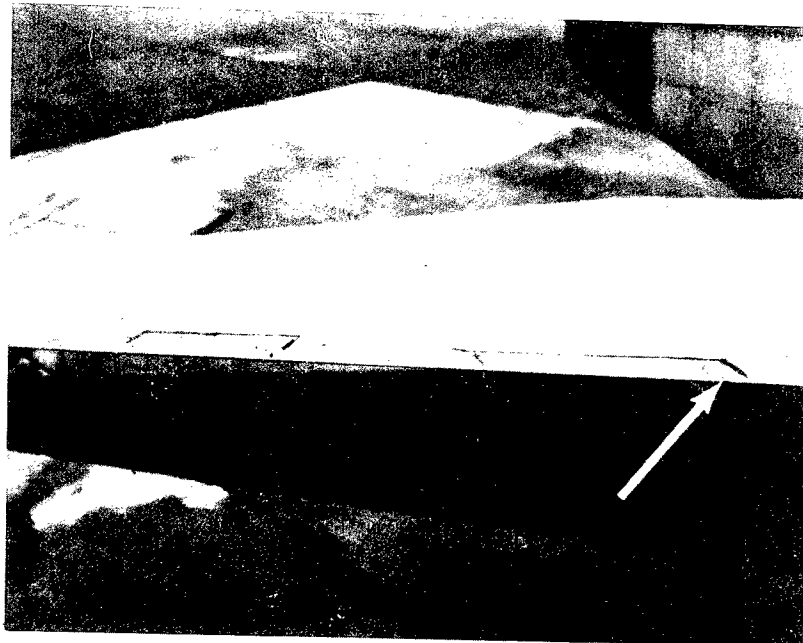
Figure 44. Slightly Peeled Section of Estane on Upper Surface of Right Stabilizer

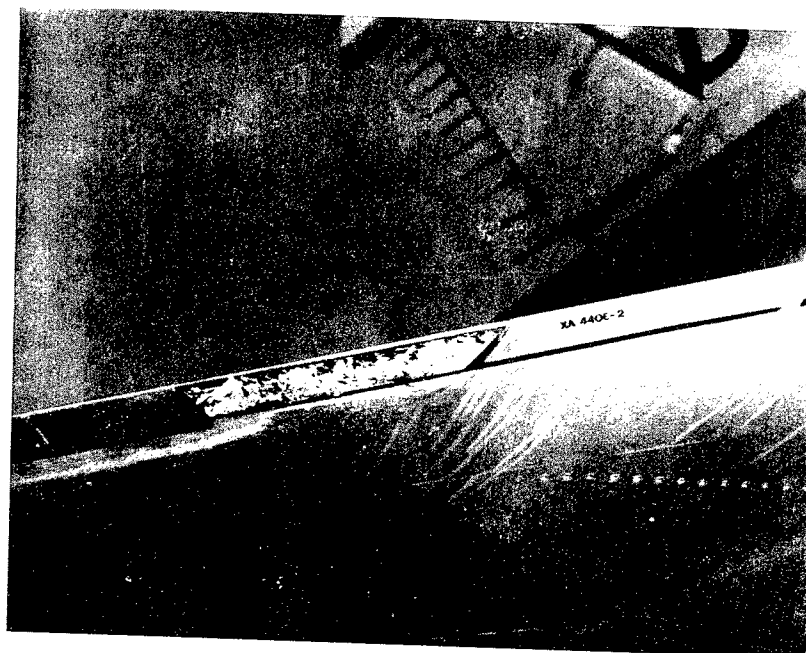
Figure 45. Corner of Estane Pulled Slightly From Lower Surface of Right Stabilizer

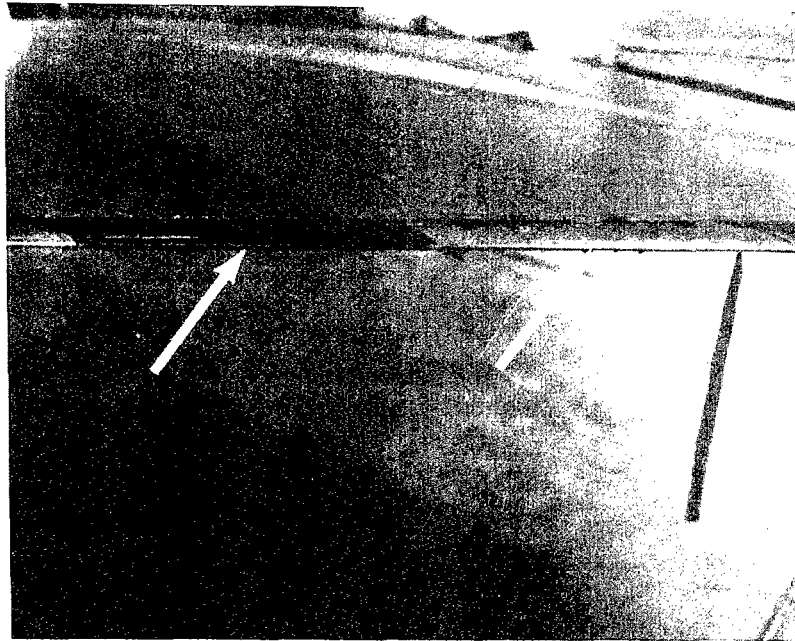
The neoprene boot on the right stabilizer showed no visible adverse effects until Flight 7 when almost all the sample was lost during the flight (Figures 46 and 47). The boot on the left stabilizer remained intact although it had cuts along the length of the boot (Figures 48 and 49). It can be speculated that the hail which was encountered shredded the missing segment on the right stabilizer. The

Figure 46. Neoprene on Upper Surface of Right Stabilizer Eroded Away During Flight 7 While Adjacent Estane Received No Damage

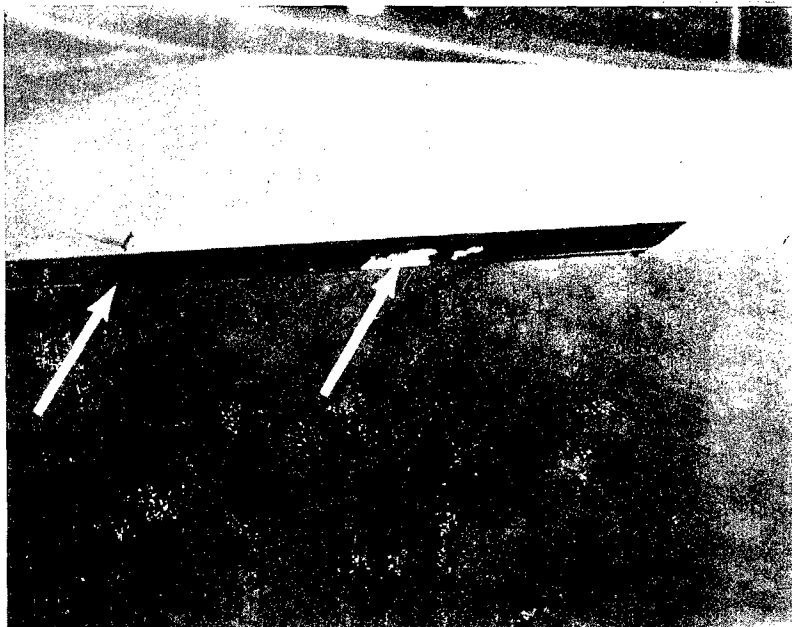
Figure 48. One Arrow Points to One of the Cuts in the Leading Edge of Neoprene on Left Stabilizer and the Second Arrow Indicates the Damage to the Hycar Boot During Flight 7

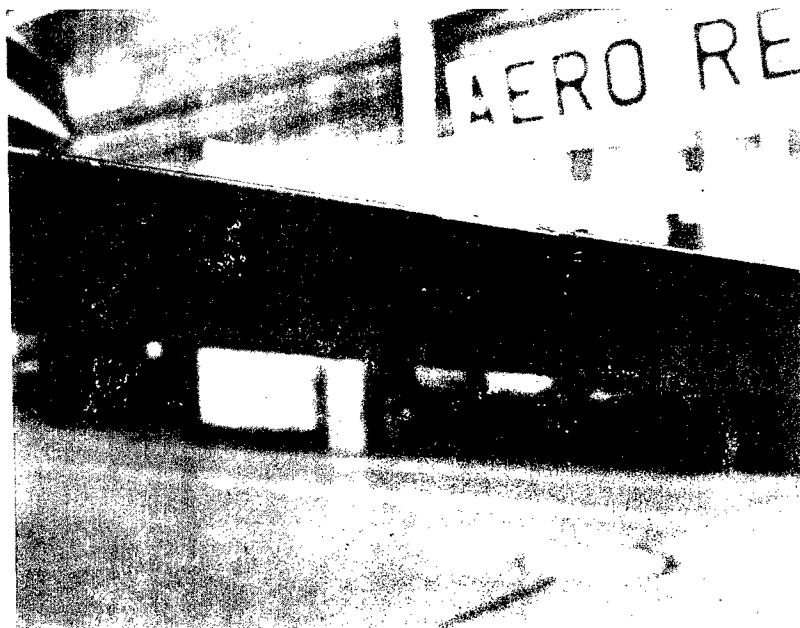
Figure 49. Damage to Neoprene and Hycar Boots on Lower Side of Left Stabilizer After Flight 7

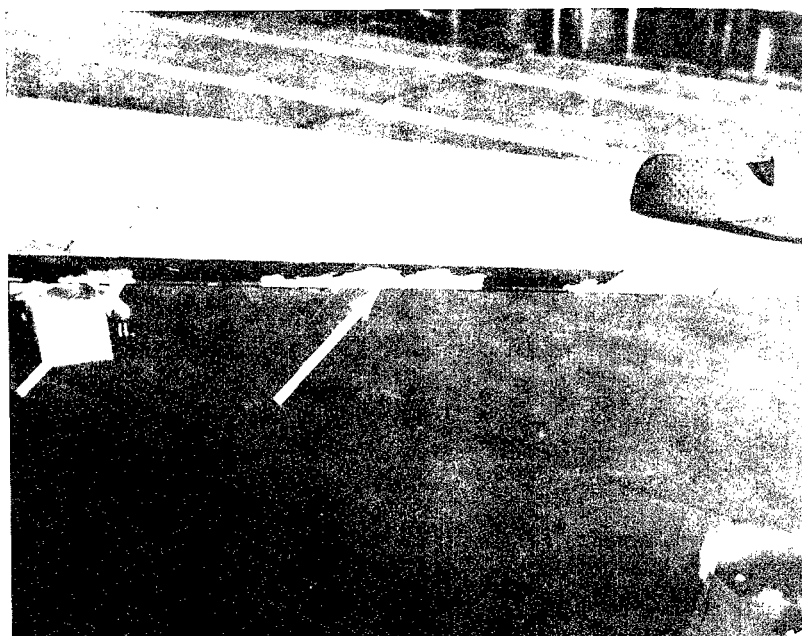
Figure 50. Increased Deterioration of Neoprene and Hycar Boots on Left Stabilizer Observed By Flight 13

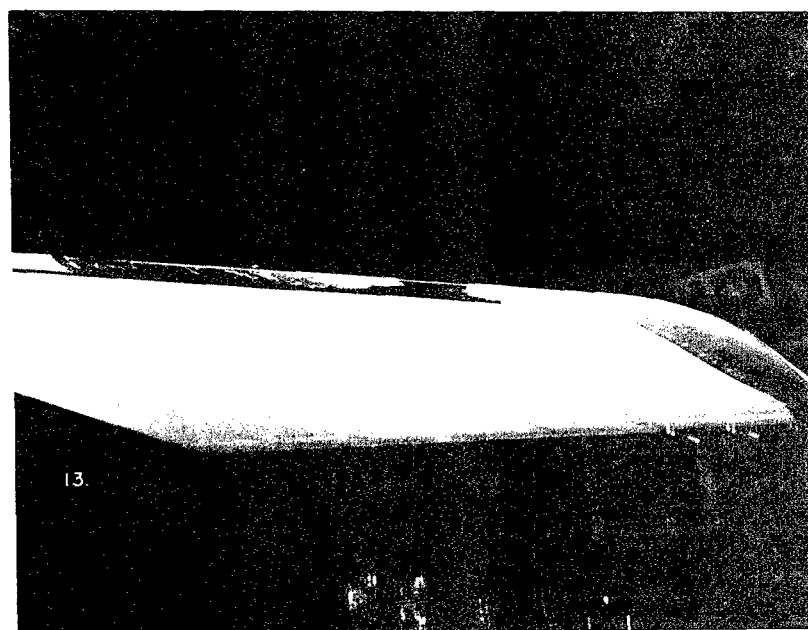
Figure 51. Damage to Neoprene and Hycar Boots on Lower Surface of Left Stabilizer After Flight 13

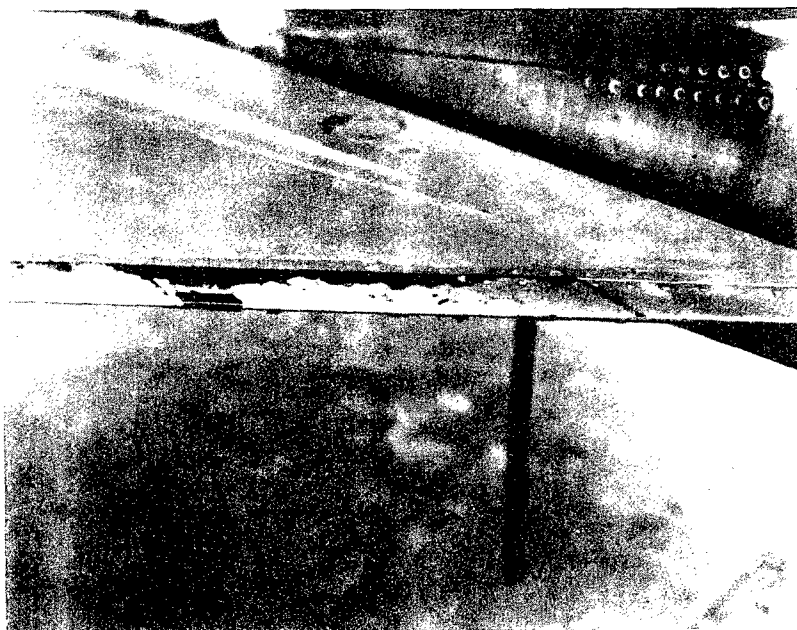
Figure 53. Hail Encounter on Flight 7 Removed Almost All the Hycar Boot From Upper Surface of Right Stabilizer

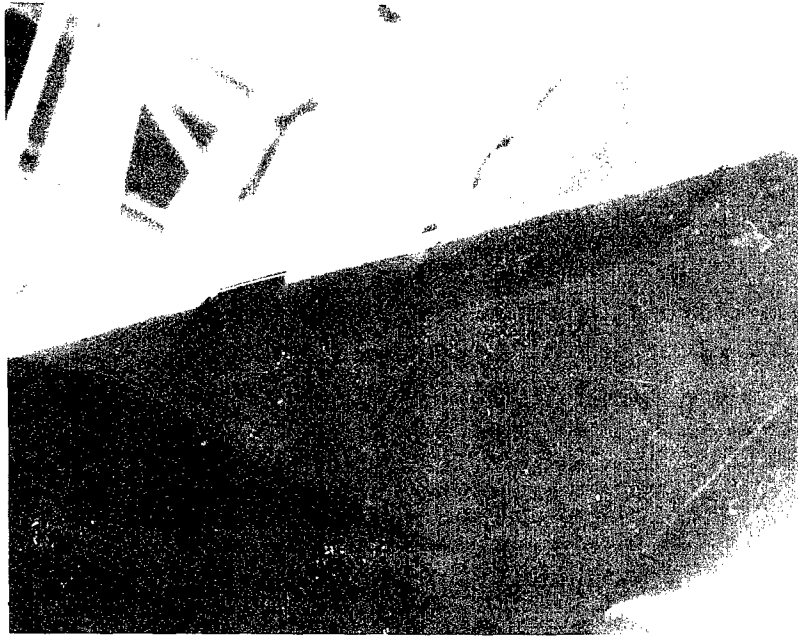
Figure 54. Severely Damaged Hycar Boot on Lower Surface of Right Stabilizer After Seventh Thunderstorm Penetration Mission

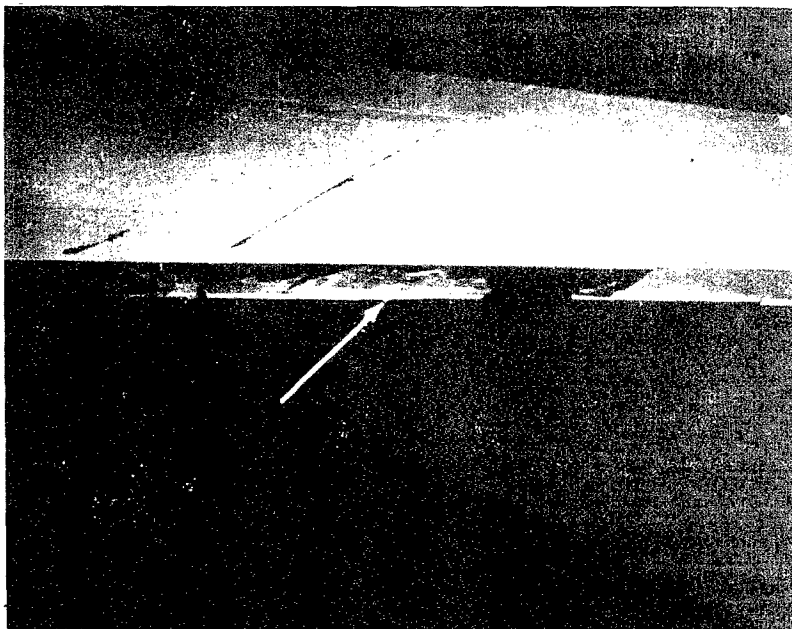
Figure 55. Three-fourths of Hycar Boot Removed From Upper Surface of Left Stabilizer During Flight 16

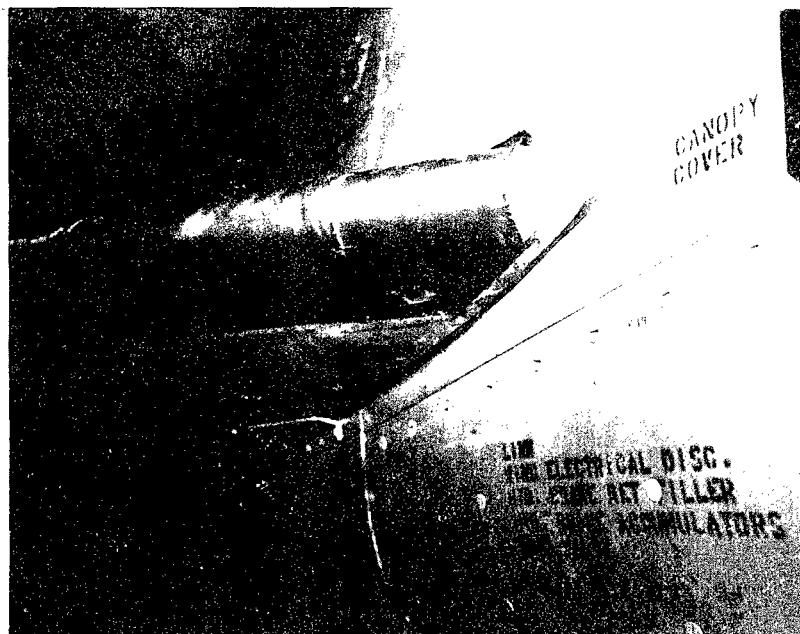
Figure 56. Edge of Slit in Deicing Boot Frayed After Flight 2

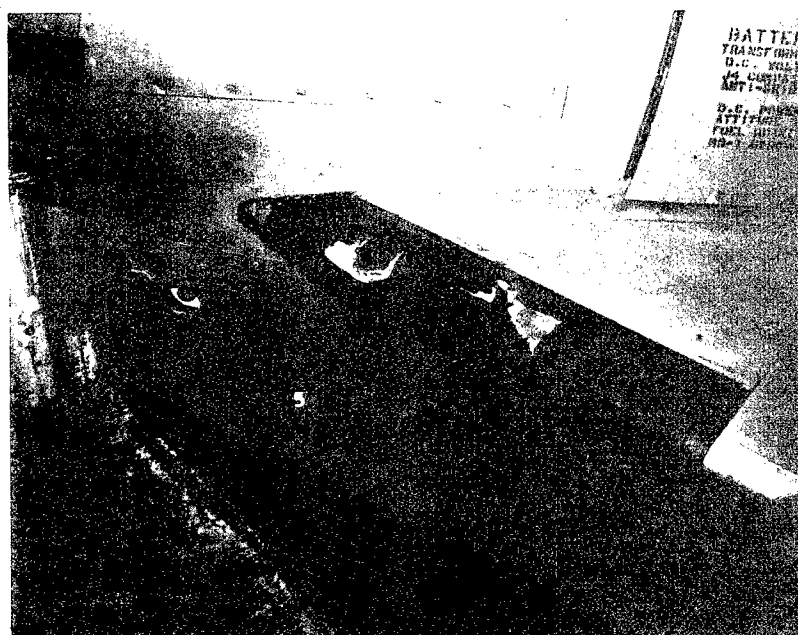
Figure 59. Increased Failure of Deicing Boot on Left Wing After Flight 3

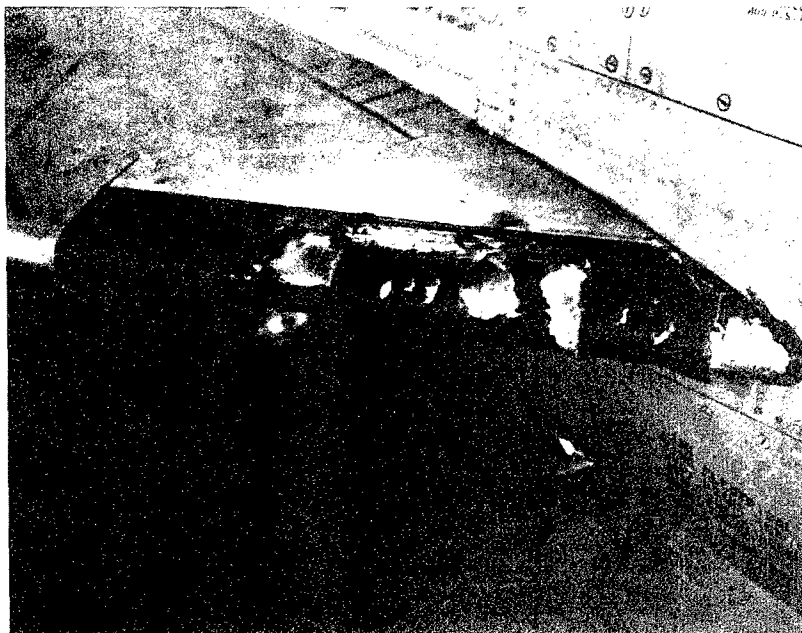
Figure 60. Severe Damage to Deicing Boot Caused by Hail and Ice Crystal Impingement During Flight 7

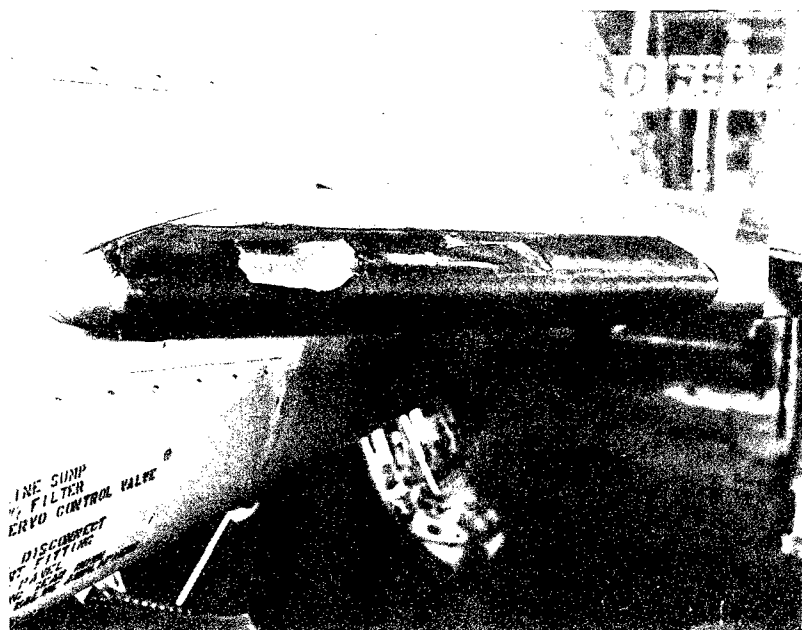
Figure 61. Significant Damage to Deicing Boot on Left Wing Caused by Hail and Ice Crystal Encounter on Flight 7

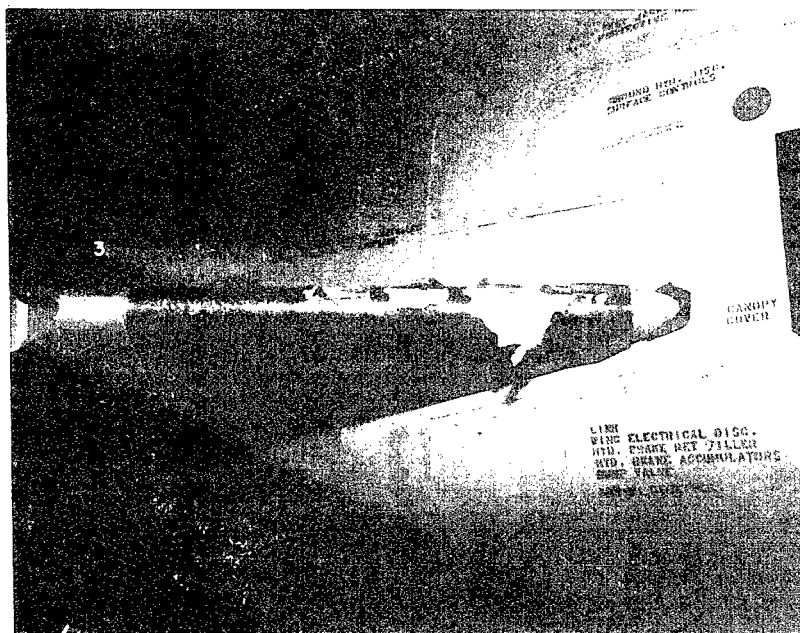
Figure 62. Severe Breakdown on Deicing Boot on Right Wing Observed After Flight 13

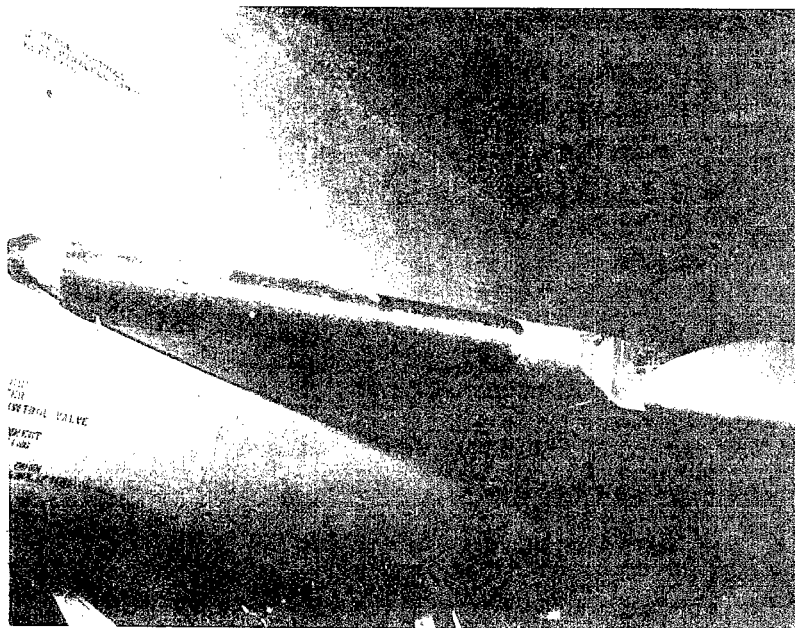
Figure 63. Increased Visible Erosion of Left Wing Deicing Boot After Flight 13

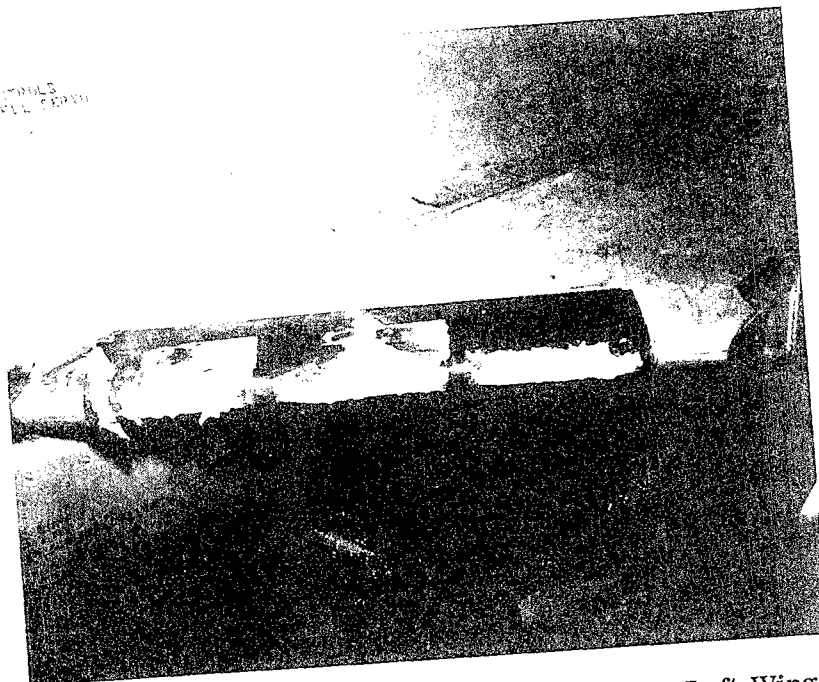
Figure 64. Complete Breakdown of Deicing Boot on Left Wing After Flight 16

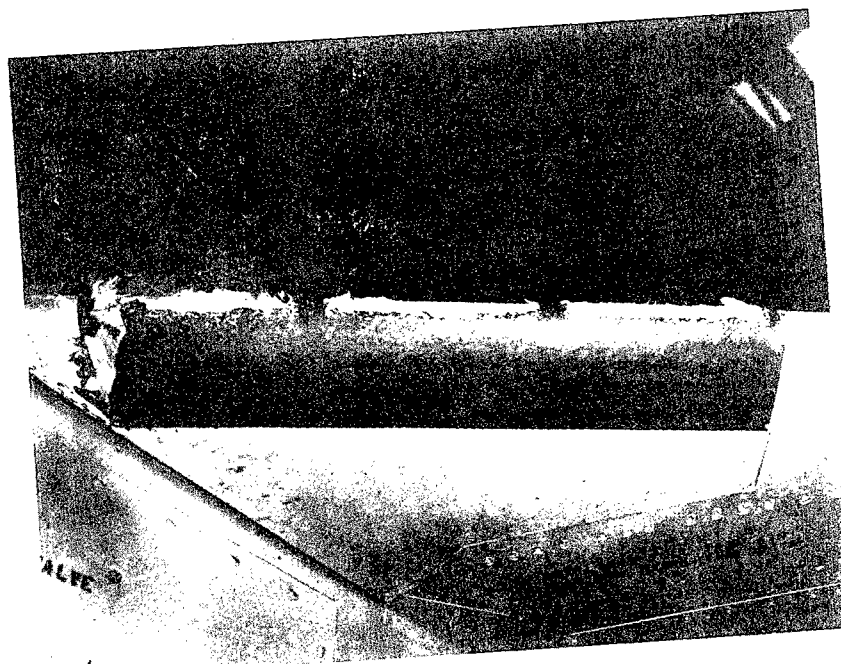
Figure 65. Section of Deicing Boot on Lower Surface of Left Wing Received Little Damage on Flight 16

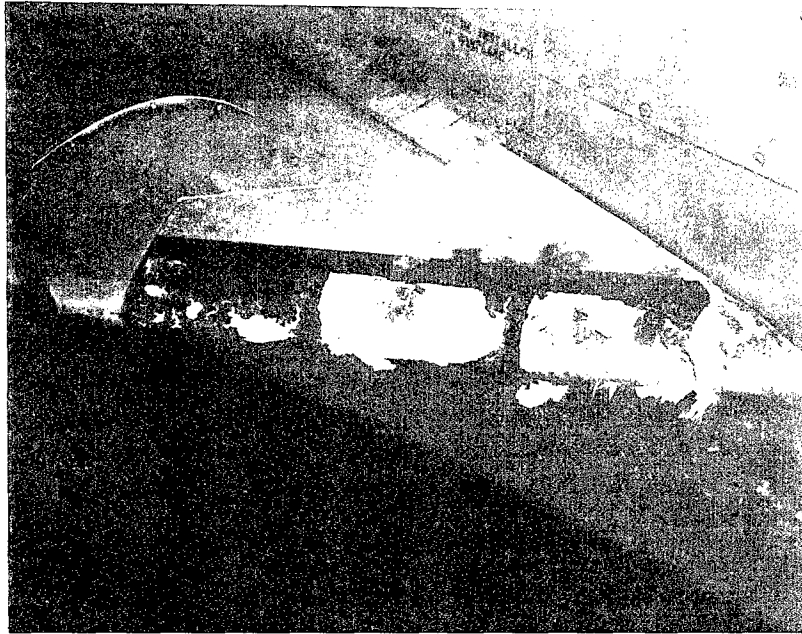
Figure 66. Surface of Deicing Boot on Upper Leading Edge of Wing Severely Damaged During Flight 16
